**MICROMETEOROID AND ORBITAL DEBRIS THREAT MITIGATION  
TECHNIQUES FOR THE SPACE SHUTTLE ORBITER**

**ABSTRACT**

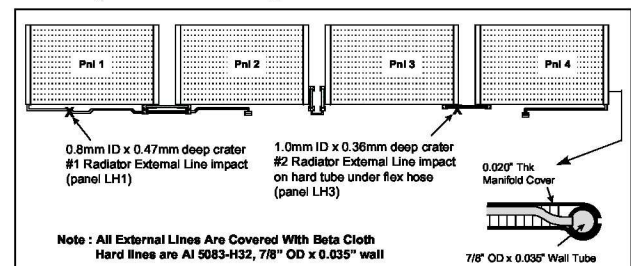
After the STS-86 mission in 1997, several significant MMOD impacts were observed on the left hand radiator interconnect lines (Fig. 2). The aluminum tubes carry Freon coolant between the thermal control system radiator panels.

Figure 2. Impacts on STS-86 LH radiator interconnect lines.

micrometeoroid particle. After this mission, an additional layer of beta cloth was added to the external radiator lines on all orbiters [6]. The STS-118 mission in 2007 experienced a large MMOD impact on the left hand #4 radiator. The impact produced a 5.5 mm diameter entry hole in the thermal tape and outer face sheet of the aluminum sandwich panel (Fig. 4). Subsequent inspections revealed a 12 mm x 19 mm exit hole in the inner face sheet of the radiator panel, with two small downstream damage sites on a thermal control system (TCS) blanket under the radiator. The payload bay door under the TCS blanket was not damaged by the impact. Analysis showed that this impact was caused by an orbital debris particle that was rich in Titanium, Zinc and Antimony.

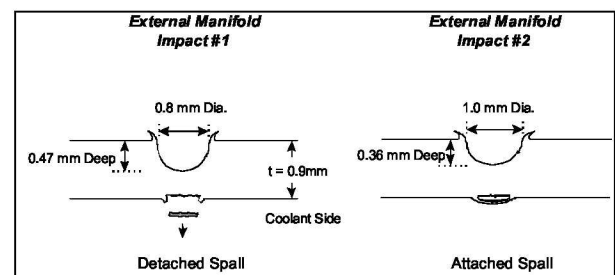
Figure 3. Impacts on STS-86 radiator interconnect lines.

The largest impact, on the external line at panel #1, penetrated just over halfway through the 0.9 mm wall thick coolant tube wall [6]. Post flight inspections determined that the site experienced detached spall on the inside surface of the tube wall, close to a tube perforation (Fig. 3). A tube leak would likely have resulted in a mission abort and possible loss of mission objectives. Post flight analysis indicated that impact #1 was caused by an orbital debris particle of stainless steel, while impact #2 was produced by a

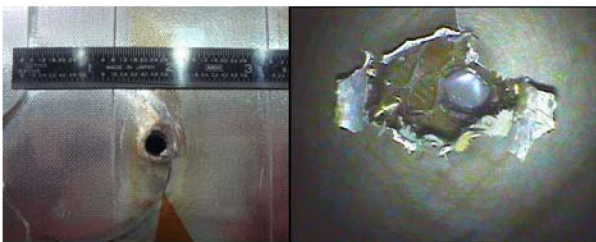
Figure 4. MMOD impacts on STS-118 LH4 radiator.
